# Professional Mold Remediation of Building and Contents (to S520 Standard – ANSI IICRC Registered Firm)

A 600m<sup>2</sup> office building in Cairns CBD

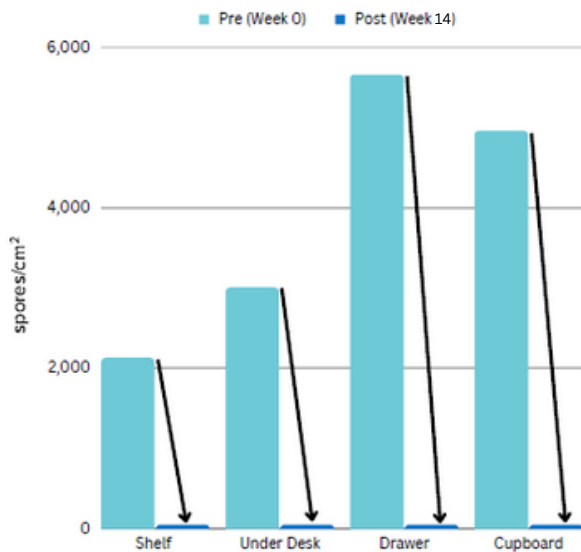
## Total Surface Fungal Spore Concentrations - General Area (Multiple Surfaces)

- Week 14 post-remediation verification results were compared to initial independent sampling results.
- The total average concentration of fungal spores was zero on all surfaces.
- After eight weeks of continuous deployment viable and nonviable total surface fungal spores concentrations demonstrated the effectiveness of Purox™ Gel when used in combination with traditional remediation.

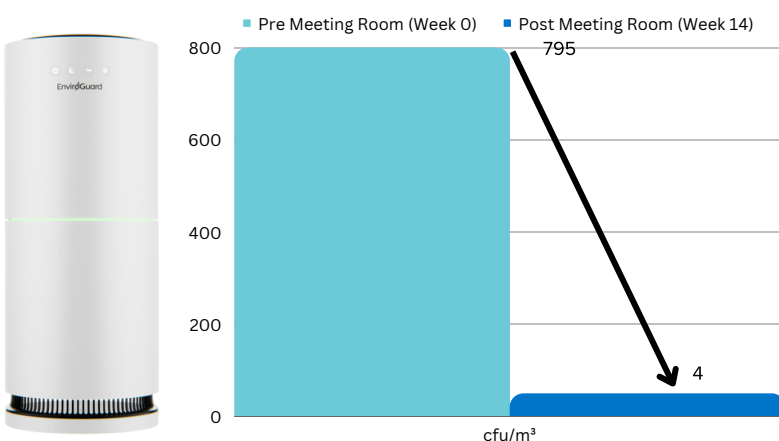
## Viable Airborne Fungi - Isolated Test Room (Air)

Post Remediation, the Airborne fungal contamination in the meeting room reduced from 795 to 4 CFU/m<sup>3</sup>.

- One heavily contaminated meeting room was selected to be a trial room. The room was approximately 84m<sup>3</sup>.
- EnviroGuard PRO™ X unit was active from containment to demobilization.
- Traditional HEPA air scrubber was not used.
- Results at PRV were exceptionally low and below levels associated with traditional remediation equipment.
